Remote Sensing of Post-Fire Geomorphological Changes Within Bennett Creek Watersheds

Aidan Cruz, Cameron Turnbow, Lindsey Hayter, Dr. Peter Nelson
Walter Scott Jr. College of Engineering and Warner College of Natural Resources

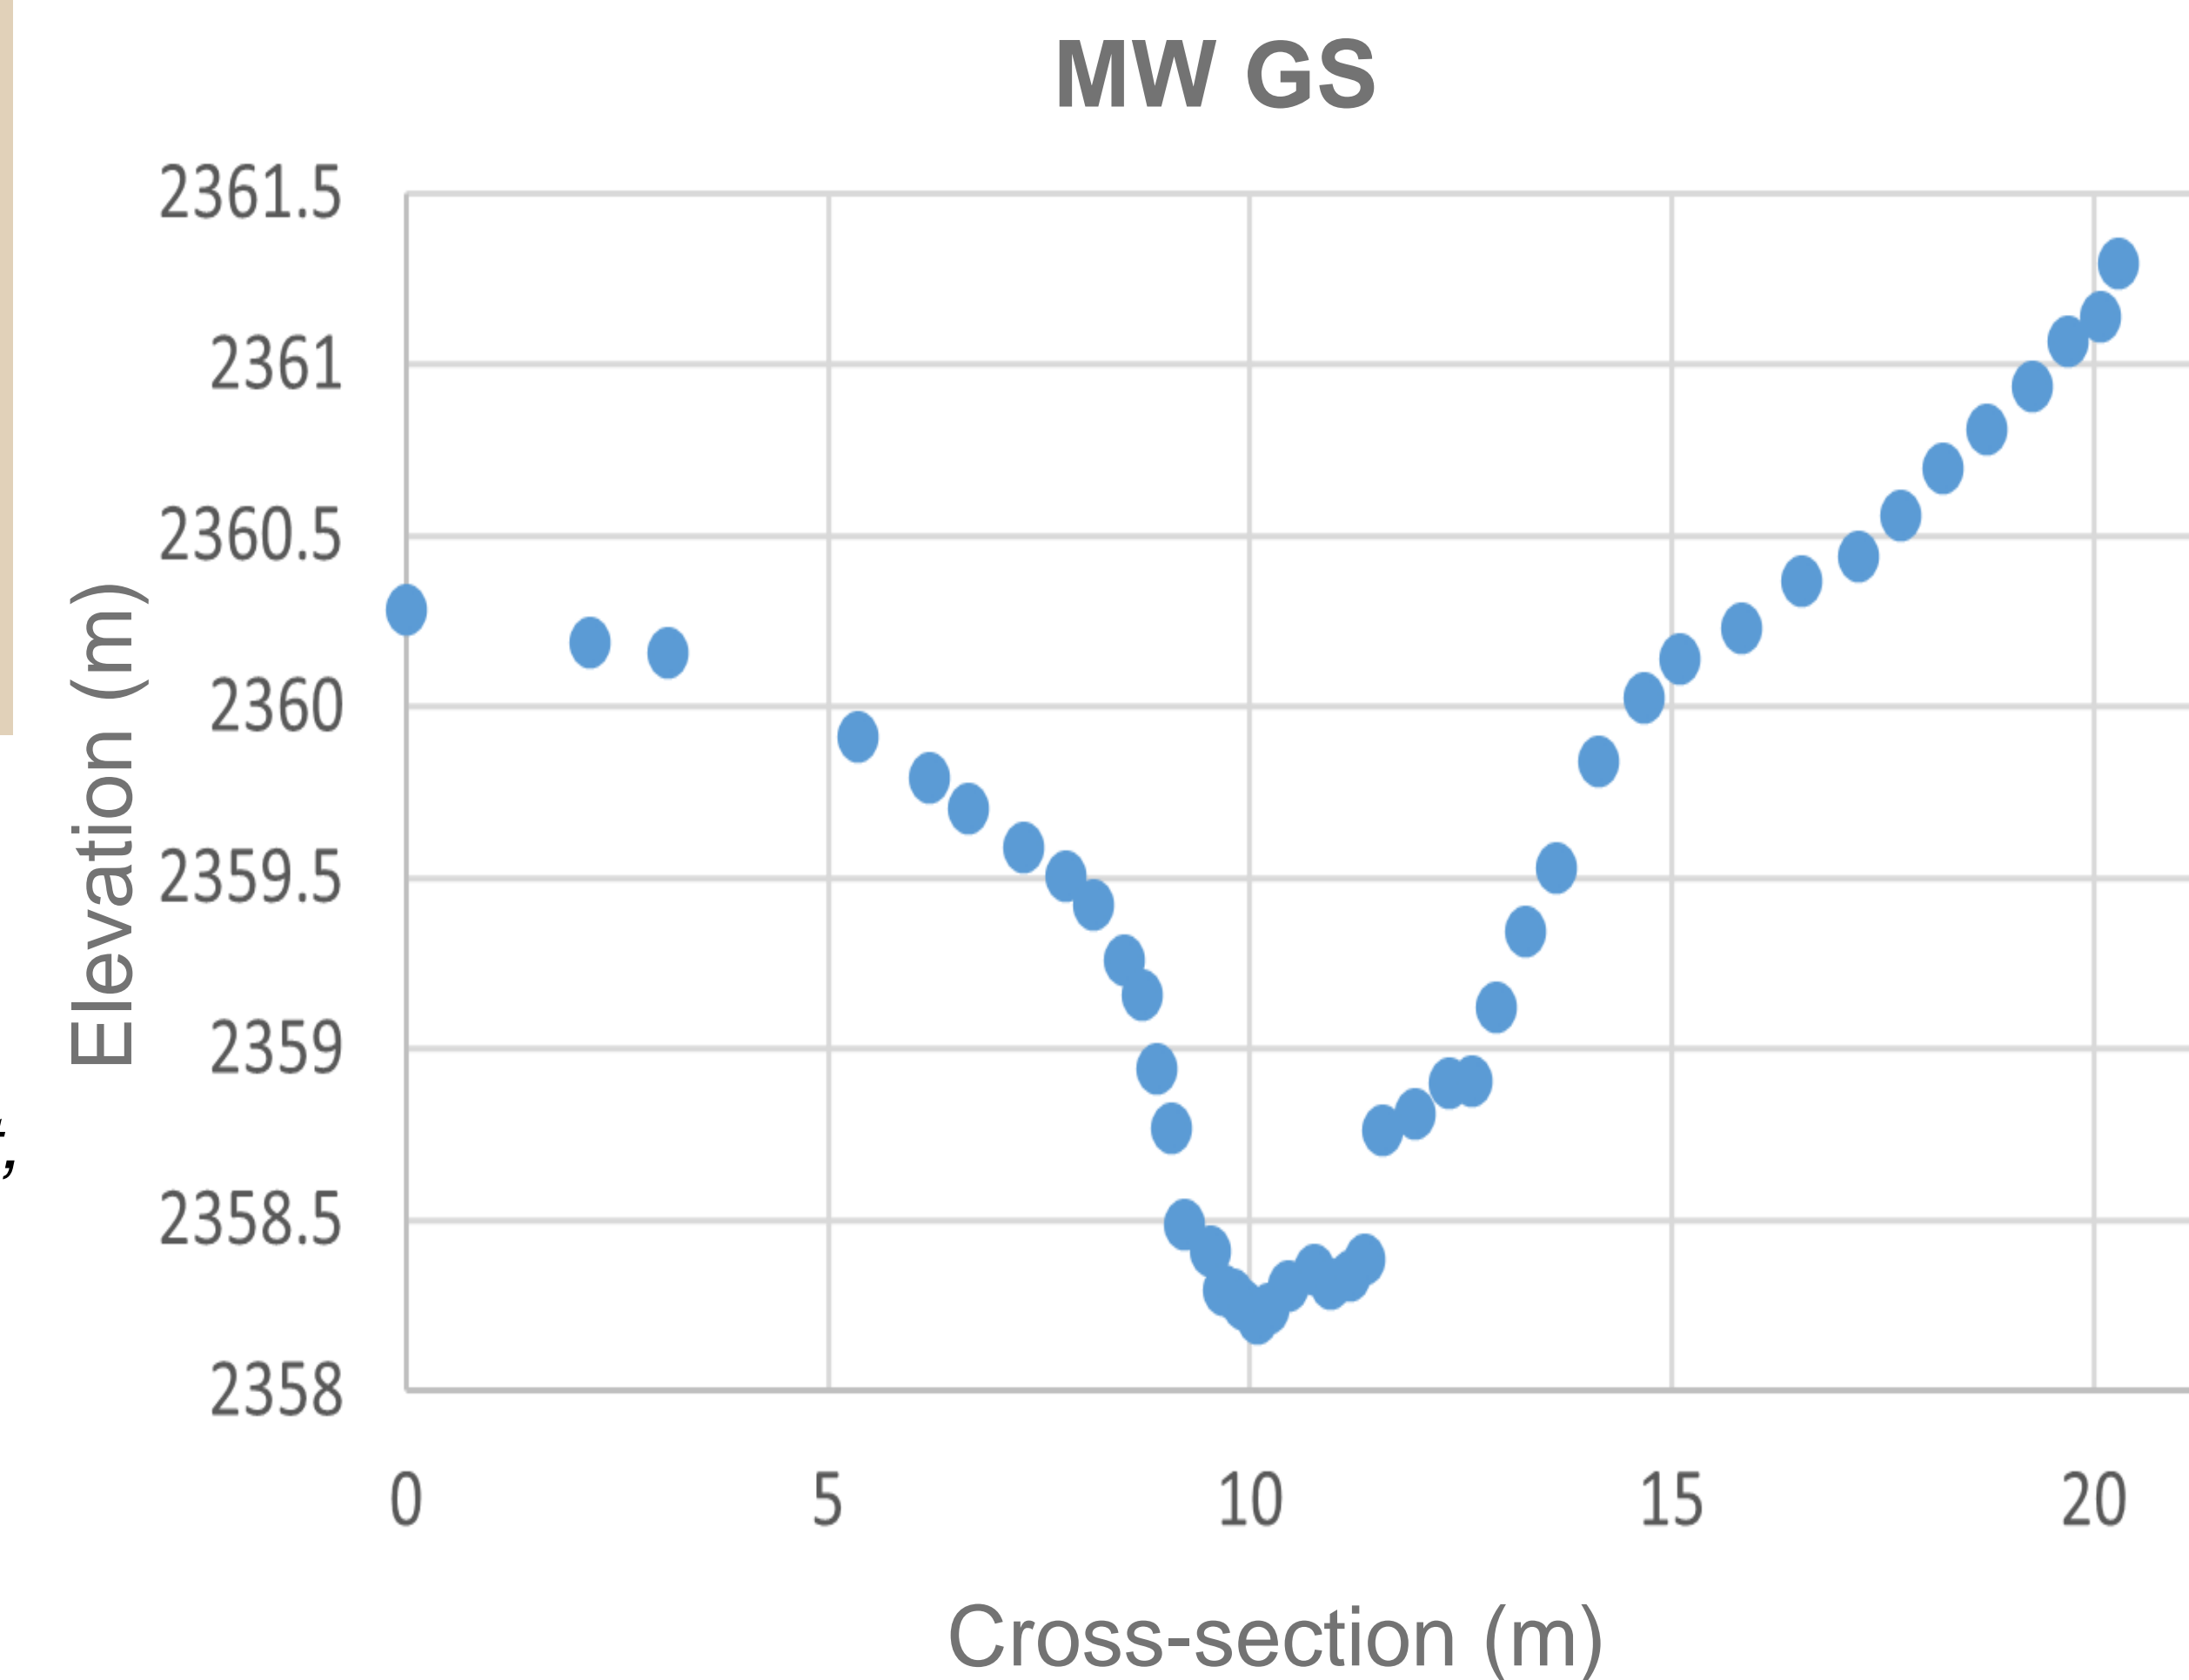
Stream Cross Section: Western delineation of the Bennett Creek watershed. Slopes of this stream were mulched at some point along its path.

- OPUS corrections are applied using the following:

$$= \sqrt{((\text{Northing}_B - \text{Northing}_A)^2 + (\text{Easting}_B - \text{Easting}_A)^2 + P_0)}$$
- Survey points run perpendicular to stream flow.
- Points are used to quantify future channel migration.
